Stamped Rocker Arm Geometry

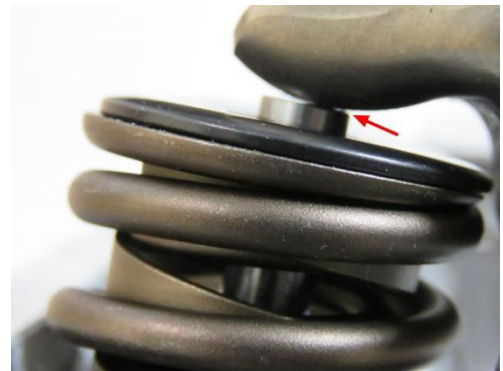
Figure 1

In Figure 1, you can see a tiny bit of light between the valve tip and the rocker pad on the rocker stud side of the valve tip. The rocker will try to push the valve stem down – this is good!

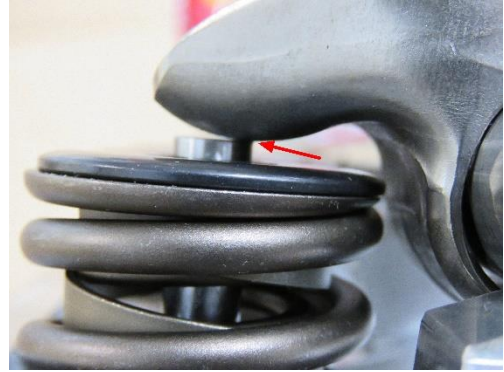
Figure 2

In Figure 2, the rocker pad is hitting on the “corner” of the stem, pushing the stem against the guide, causing it to wear – this is bad.

Raise the rocker trunion. A small washer (approximately .040” thick) usually takes care of the problem. If you use a washer that is too thick, you may reduce the lifter pre-load and make the lifter noisy.
