TTi Performance Exhaust and Headers
 Tube Technologies, Inc.
 Corona, California 92880-1726
 Phone (951) 371-4878

TORQUE SHAFT ASSEMBLY
71-74 B-body & 70-74 E-body
Column Shift applications

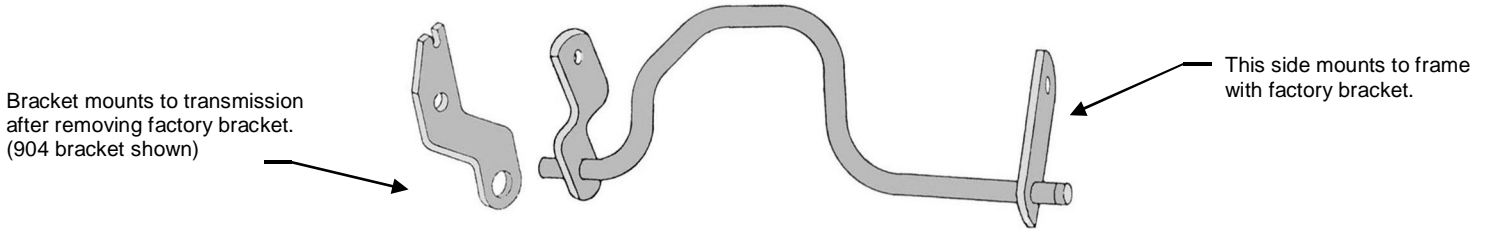
This precision bent Torque Shaft Assembly with laser cut ends go up and over the Header tubes or Exhaust Pipe which allows you to maintain your column shift linkage and is a direct bolt-on replacement of your stock straight torque shaft rod.

Transmission: 727 P/N: B7174TSA-7 (Narrow bracket), 904 P/N: B7174TSA-9 (Wide bracket)
